National Transportation Safety Board Aviation Accident Preliminary Report

Location:	Beaufort, NC	Accident Number:	ERA22LA120
Date & Time:	February 13, 2022, 14:02 Local	Registration:	N79NX
Aircraft:	PILATUS AIRCRAFT LTD PC-12/47E	Injuries:	8 Fatal
Flight Conducted Under:	Part 91: General aviation - Personal

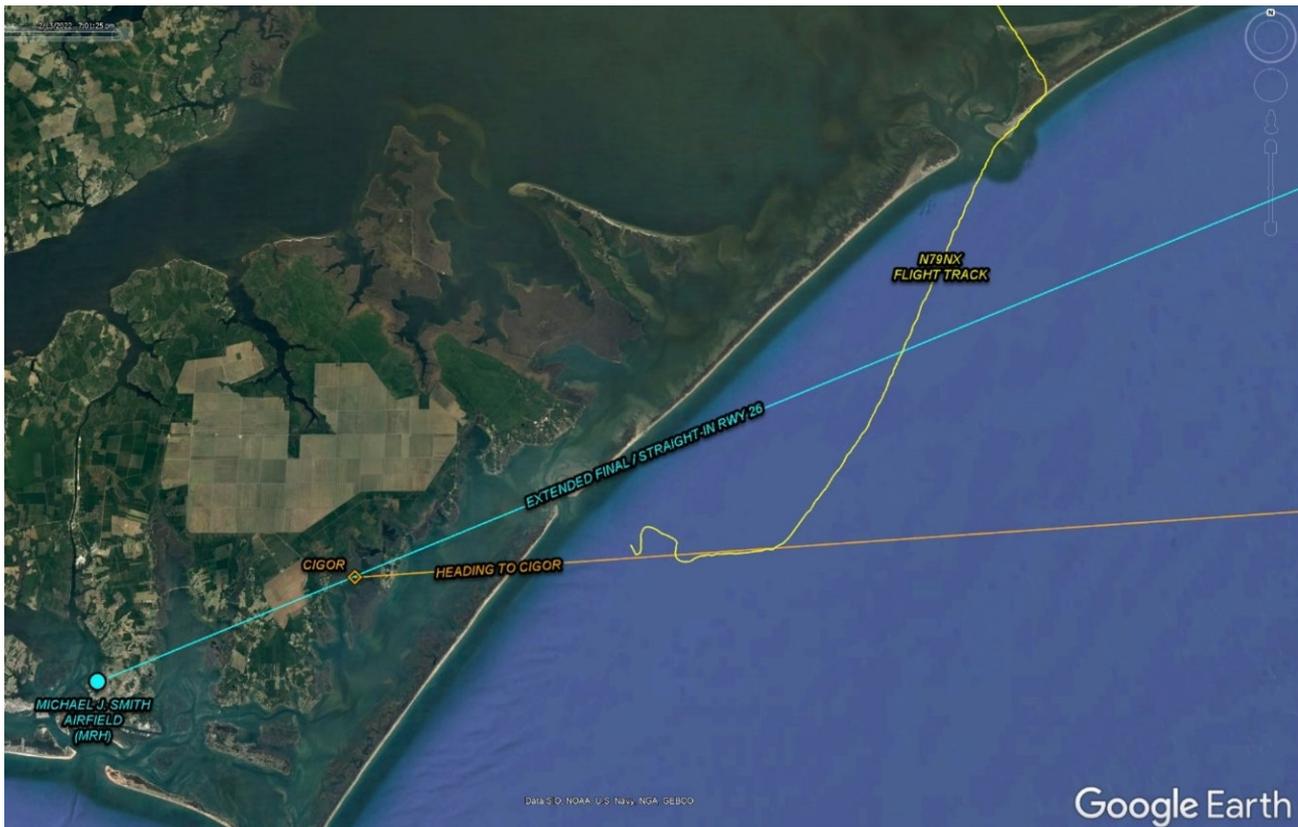
At 1401, the controller called the airplane and asked what altitude it was at because the airplane was at 4,700 ft msl and climbing quickly. There was no response. Radar contact was lost with the airplane at 1402 and an ALNOT was issued at 1429. Throughout the communication with air traffic control, there were no distress calls or a declaration of emergency from the airplane.

Figure 1. Airplane flight track (yellow) overlaid with the heading to the initial approach fix (orange) and the destination extended runway centerline (blue).
